Title:	Flagpole in the Library car park leaning.
Description	One of the flagpoles in the Library car park is leaning
Owner:	BPC
Area:	Amenity
Status	BVS/BPC investigating
Last Updated:	14/01/2024

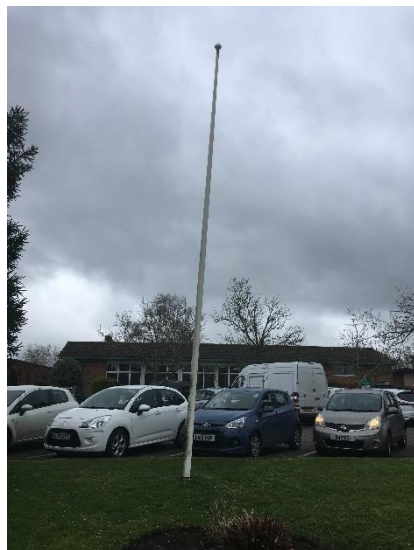
One of the flag poles in the library car park is leaning. Last year the BVS replaced the halyards on both flagpoles. The flagpole was leaning then. On checking the base, it appears that the concrete base has shifted. It may be possible to correct the lean by 'shimming' the base plate hinge.

Date	Action by	Action/Event
14/01/2024	BVS	Investigate best way to correct lean.
